NAVAL POSTGRADUATE SCHOOL  
Monterey, California

THESIS

AN INVESTIGATION OF PLASMA - SURFACE  
INTERACTIONS ON SELECTED  
CONDUCTORS AND INSULATORS.

Dec 1980

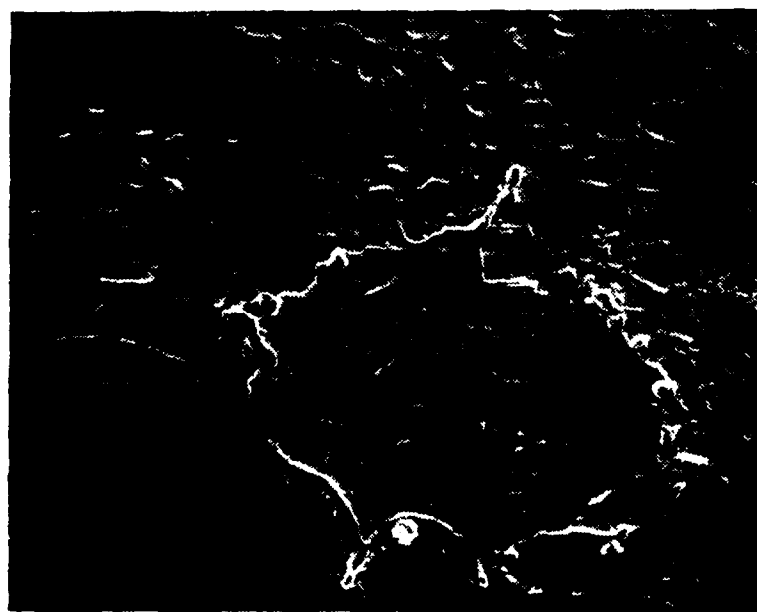
FIGURE 9. UNCOATED STAINLESS STEEL CENTRAL CRATER IRRADIATED IN A VACUUM. THE DIMPLED AREAS ARE CAUSED BY UNIPOLAR ARCS. (200X SEM)

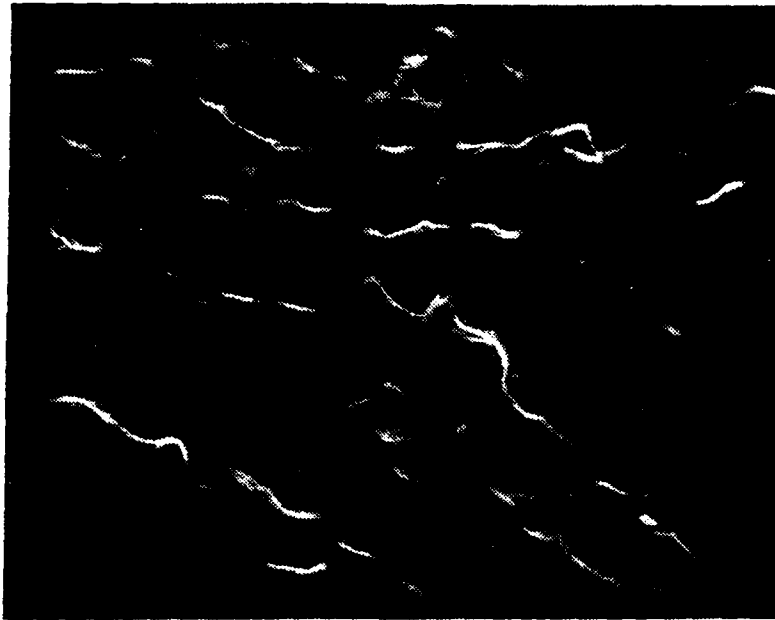
FIGURE 10. VACUUM IRRADIATED STAINLESS STEEL. THIS VIEW IS A MAGNIFICATION OF THE OUTER PERIMETER OF THE CRATER SHOWN IN FIGURE 9. (500X SEM)

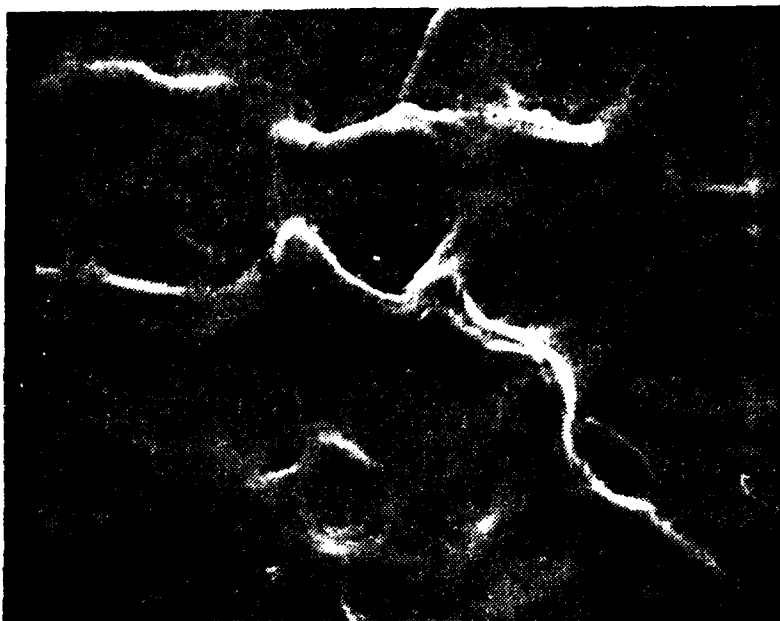
FIGURE 11. VACUUM IRRADIATED STAINLESS STEEL. THIS VIEW IS AN ENLARGEMENT OF CENTER OF FIGURE 10 SHOWING PLASMA DAMAGE AT THE PERIMETER OF THE CENTRAL CRATER. (1000X SEM)

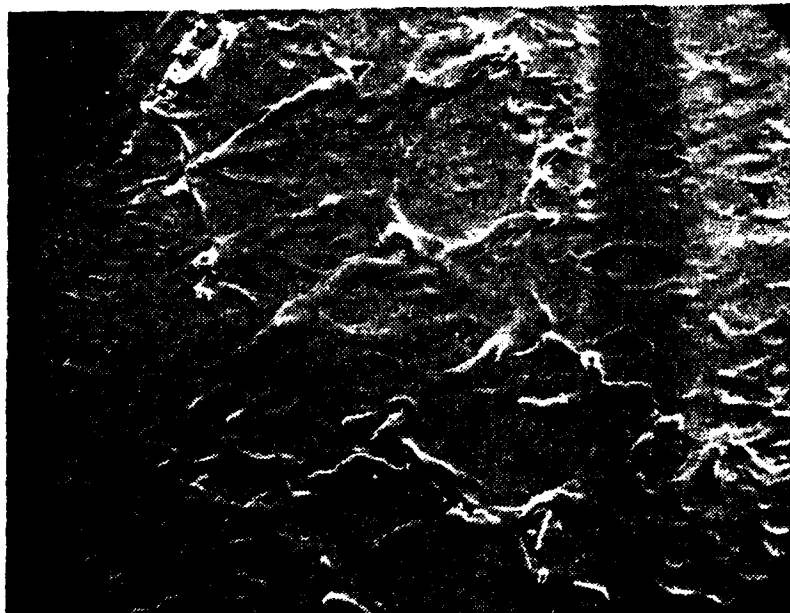
FIGURE 12. VACUUM IRRADIATED STAINLESS STEEL. THIS VIEW SHOWS THE CENTER OF MAIN LASER DAMAGE AREA. NOTE UNIPOLAR ARC CRATERS. (200X SEM)

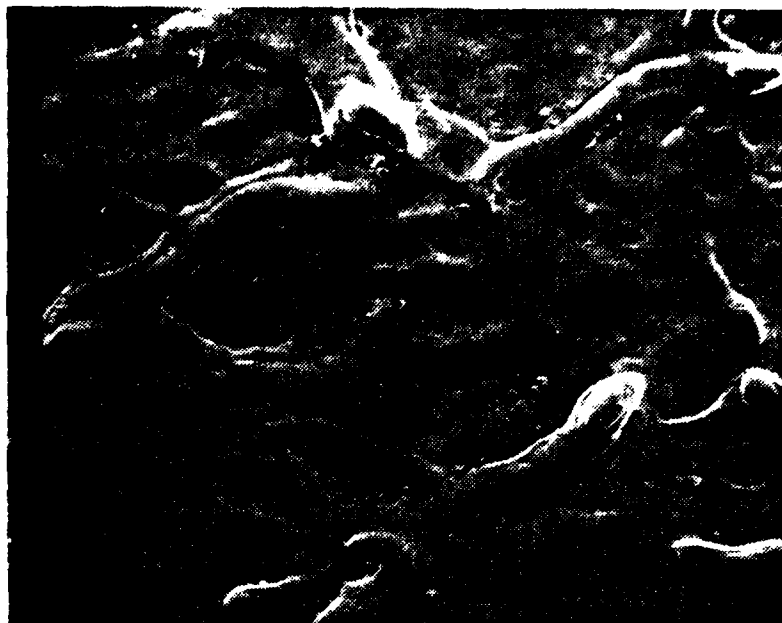
FIGURE 13. VACUUM IRRADIATED STAINLESS STEEL. THIS IS AN ENLARGEMENT OF THE CENTRAL CRATER SHOWING MOLTEN CENTER. (500X SEM)

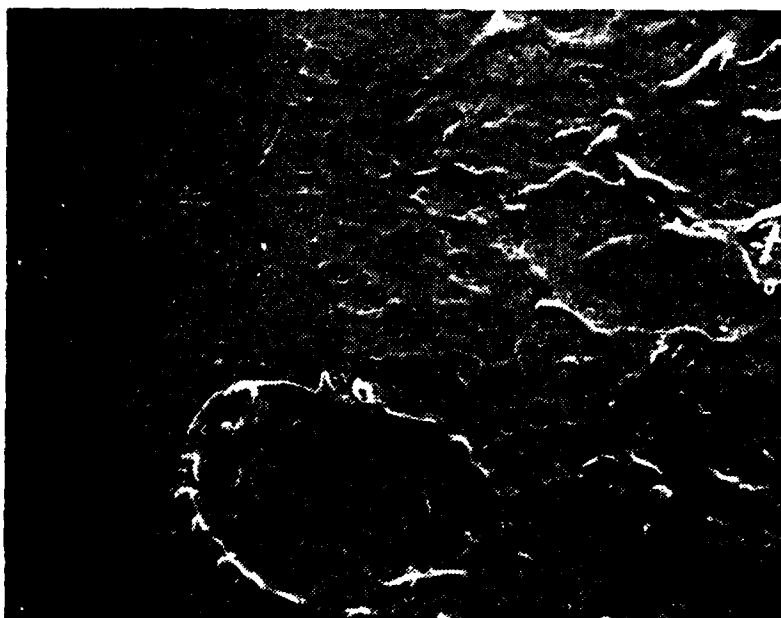
FIGURE 14. VACUUM IRRADIATED STAINLESS STEEL. THIS VIEW SHOWS THE OUTER PERIMETER OF THE CENTRAL CRATER. THE CENTRAL CRATER IS TO THE RIGHT. NOTE THE PLASMA DAMAGE CAUSED BY UNIPOLAR ARCS AS THE PLASMA CLOUD EXPANDED ACROSS THE STEEL. (200X SEM)

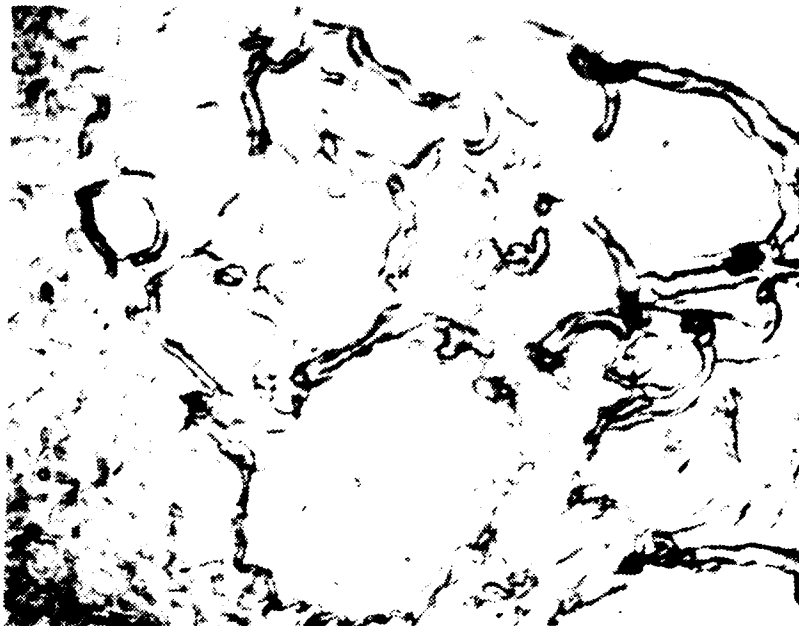
FIGURE 15. STAINLESS STEEL IRRADIATED IN AIR. THIS OPTICAL MICROSCOPE VIEW SHOWS THE CENTRAL CRATER WITH A LARGE MOLTEN AREA, MANY SMALL CRATERS ARE PRESENT. (100X)

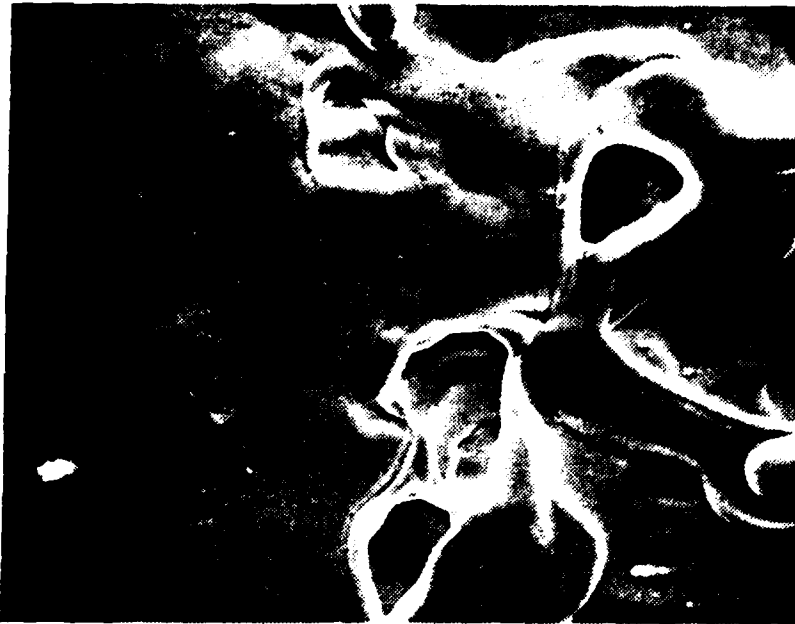
FIGURE 17. AIR IRRADIATED STAINLESS STEEL. THIS VIEW SHOWS THE MOLTEN AREA IN THE CENTRAL CRATER. (1000X SEM)

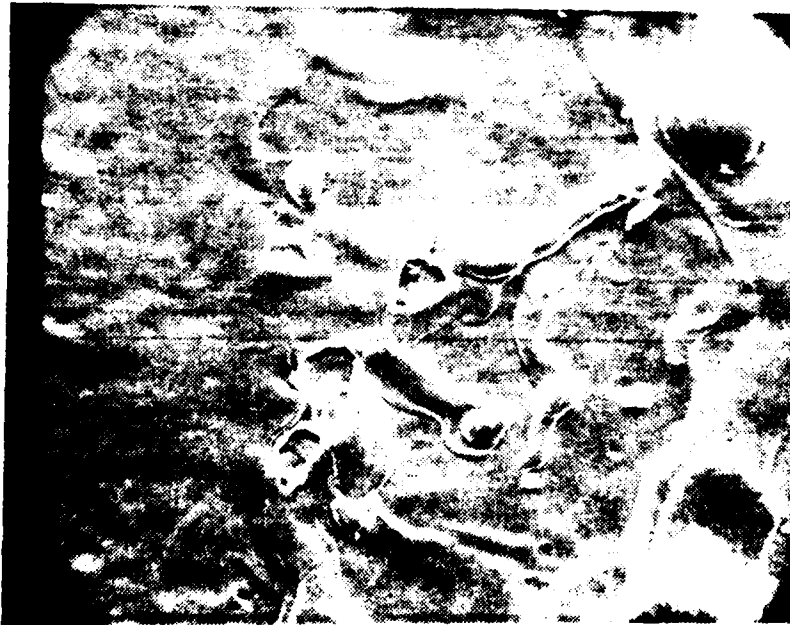
Figure 18 gives a wider field of view at 500X of the area shown in Figure 17. A few dimples and craters can be seen at the edges of the photograph. The diameter of the

FIGURE 18. WIDE ANGLE VIEW OF AIR IRRADIATED STAINLESS STEEL. THE MAIN CRATER IS TO THE RIGHT. THE ONSET OF PLASMA DAMAGE CAN BE SEEN AT THE LEFT. (500X SEM)

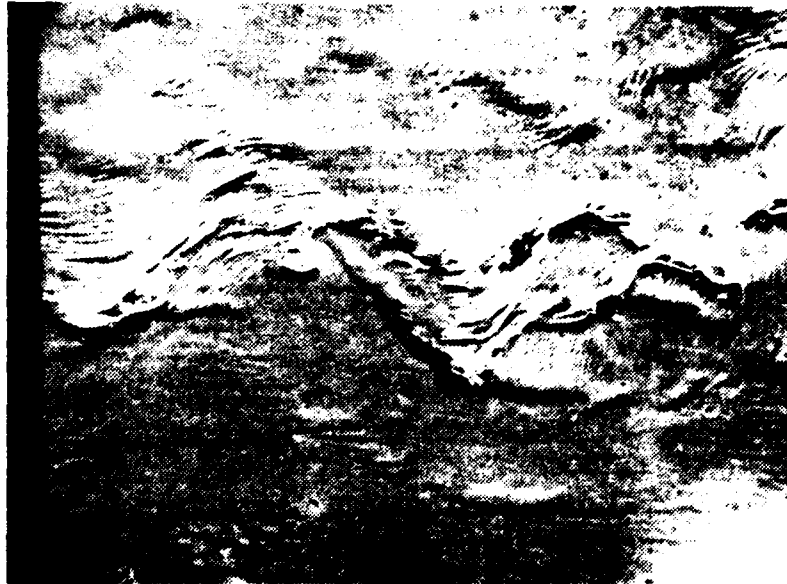
damaged area is 2.0 mm. The main crater is 25  $\mu$ m deep and is 0.88 mm in diameter. Figures 19 and 20 were taken beyond the perimeter of the laser impact area. These photographs show craters caused by unipolar arcing. The arc craters are 3 to 4  $\mu$ m in diameter.

FIGURE 19. AIR IRRADIATED STAINLESS STEEL. THIS IS A VIEW OF THE OUTER PERIMETER OF THE MAIN CRATER AND SHOWS WHERE THERMAL EFFECTS STOPPED. NOTE UNIPOLAR ARCING CRATERS AT THE BOTTOM OF THE PHOTOGRAPH. (500X SEM)

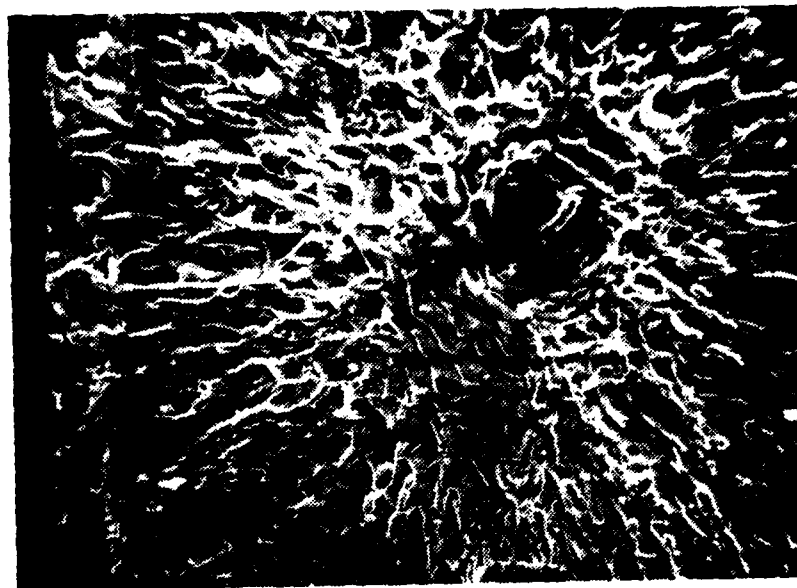
The center of the 25  $\mu$ m deep main crater is shown in Figure 31. The layered rosette pattern indicates that the copper sample was in a highly molten state for a relatively long time. Figures 32 to 34 show the many dimpled craters formed around the outer perimeter of the damaged area. The larger craters were formed first while the younger craters appear as small dimples. The many new craters, seen at the top of Figure 33, average .002 mm in diameter. The larger craters are .015 mm in diameter and 2 to 4  $\mu$ m deep.

FIGURE 31. COPPER IRRADIATED IN A VACUUM. CENTER OF LASER IMPACT AREA. (500X SEM)

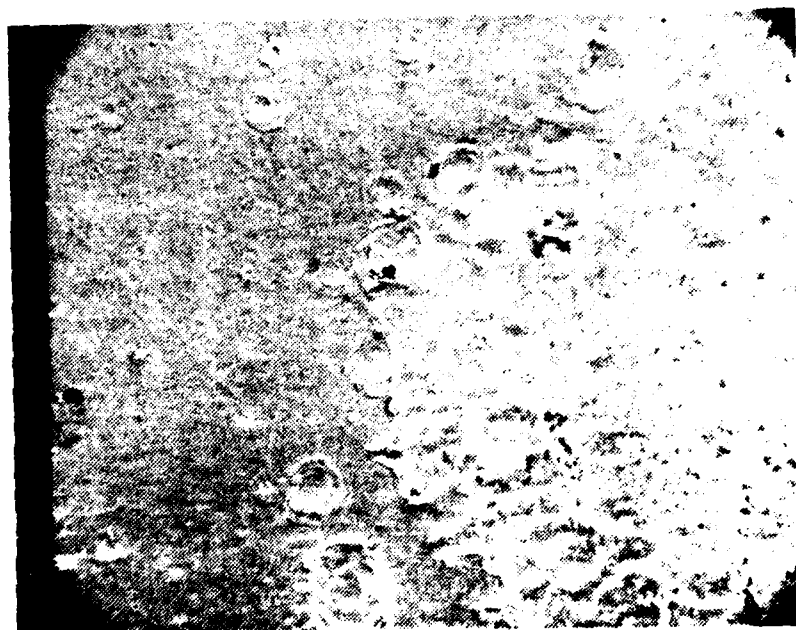
FIGURE 32. COPPER IRRADIATED IN A VACUUM. PERIMETER OF PRIMARY DAMAGE AREA SHOWING UNIPOLAR ARCING CRATERS. (500X SEM)

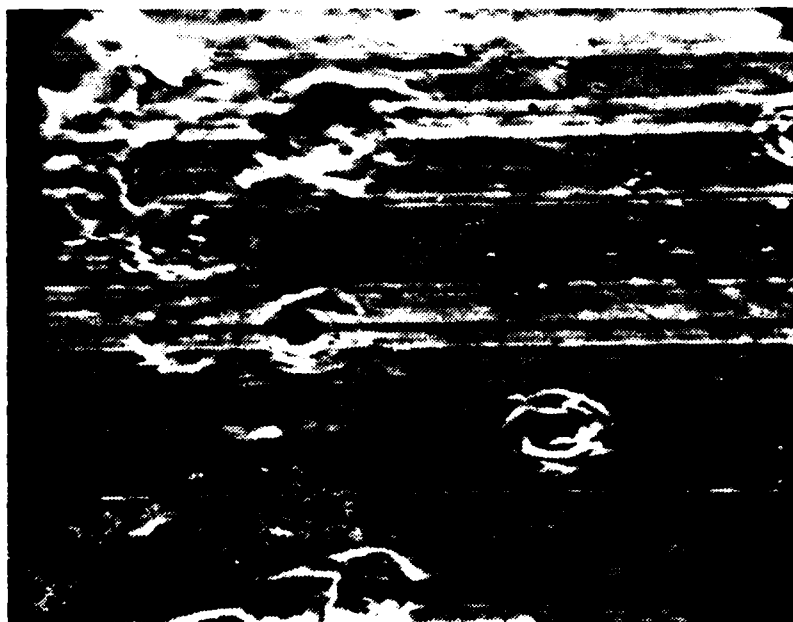
FIGURE 34. COPPER IRRADIATED IN A VACUUM. VIEW OF UNIPOLAR ARCING CRATERS.  
(1000X SEM)

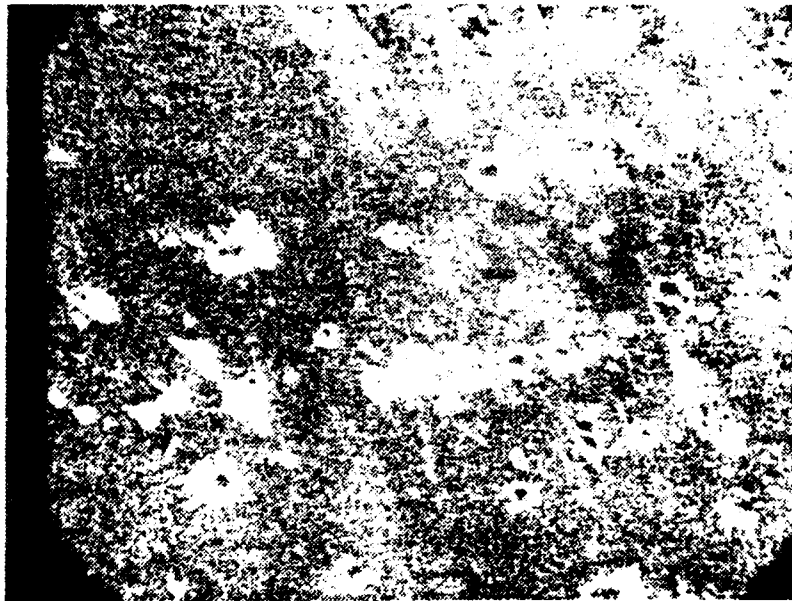
FIGURE 37. COPPER IRRADIATED IN AIR SHOWING UNIPOLAR ARCING CRATERS.  
(500X SEM)

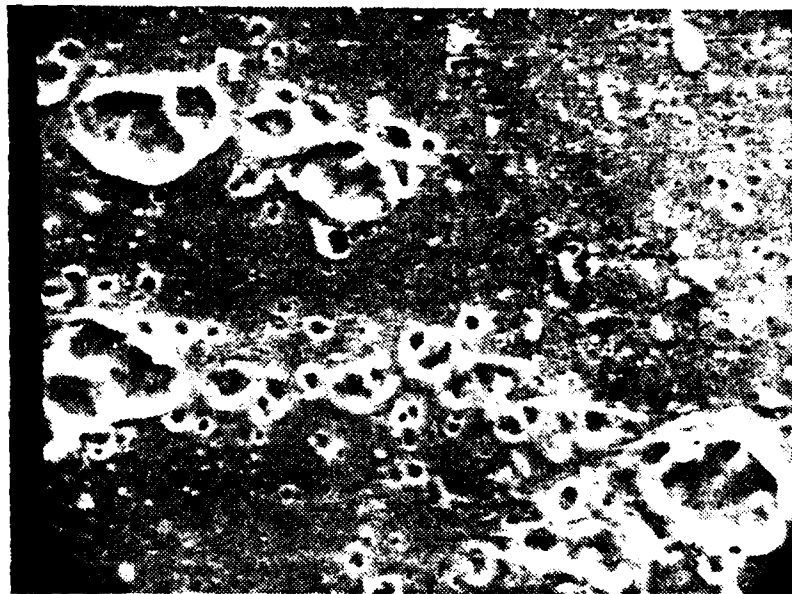
FIGURE 49. TIN. MAGNIFIED VIEW OF UNIPOLAR ARCING CRATERS. (1000X SEM)

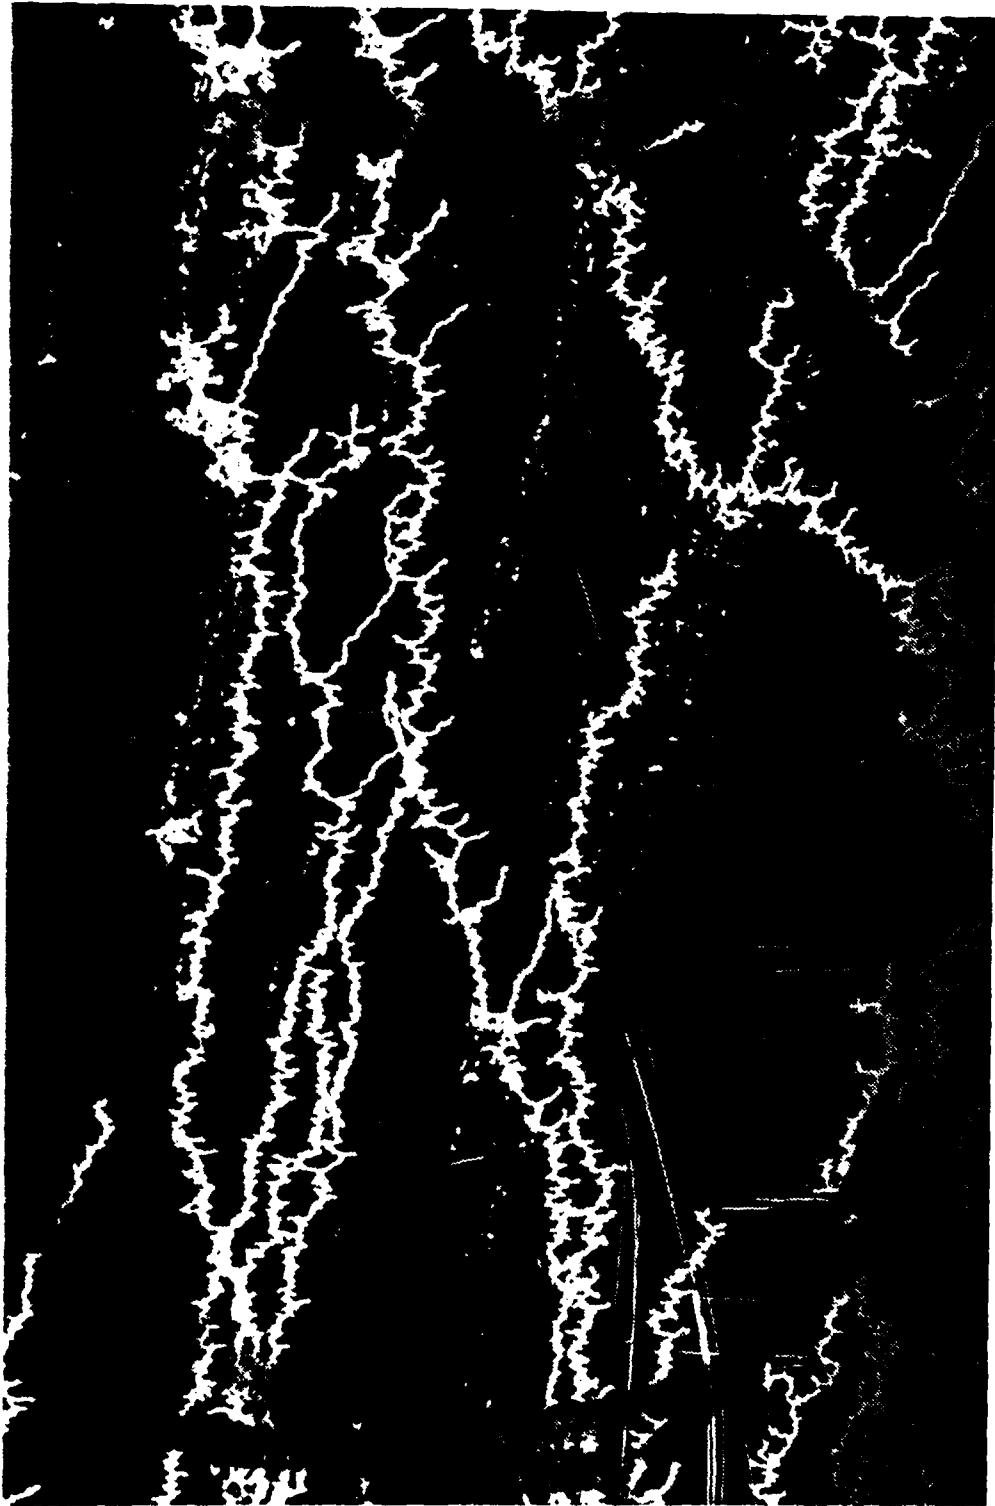
Two basic types of arcing tracks can be seen on this sample. The distinct branched tracks seen in Figure 61 appear very different from the smaller random track pattern shown in Figure 62. Figure 63 is an enlarged view of the tracks seen in Figure 61. The undamaged titanium coatings appear as grey areas while the arcing tracks are black. The arcing tracks average 0.07 mm in width. Figures 64 and 65 are enlarged views of one of the tracks. These tracks are formed by a large number of craters which have destroyed the titanium coating. Figure 65 shows a roughened surface where the titanium has been eroded from the glass. From these photographs, it is difficult to determine if the glass substrate has been damaged. The roughened surface could have been caused either by damage

FIGURE 61. ENLARGED VIEW OF TITANIUM COATED GLASS SURFACE SHOWING ARC TRACKS.

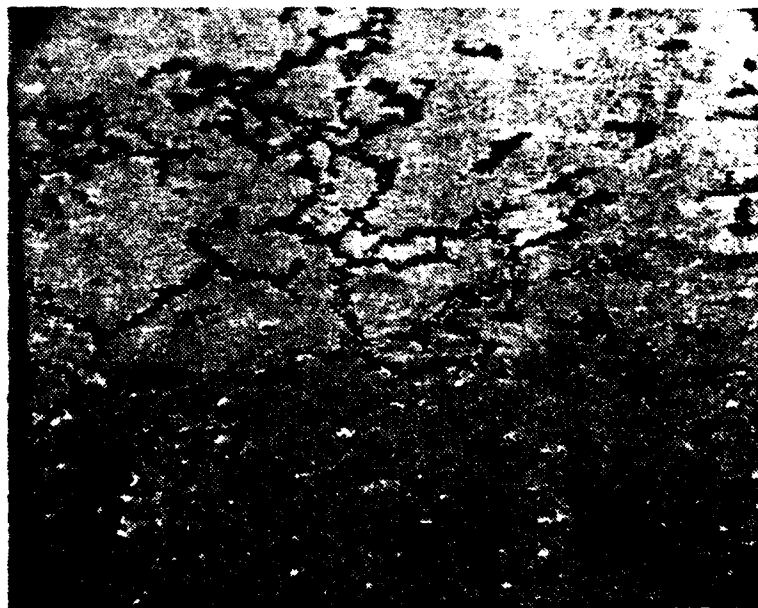
FIGURE 66. GLASS COATED WITH TITANIUM. VIEW OF THE SMALLER ARC TRACKS. (50X SEM)

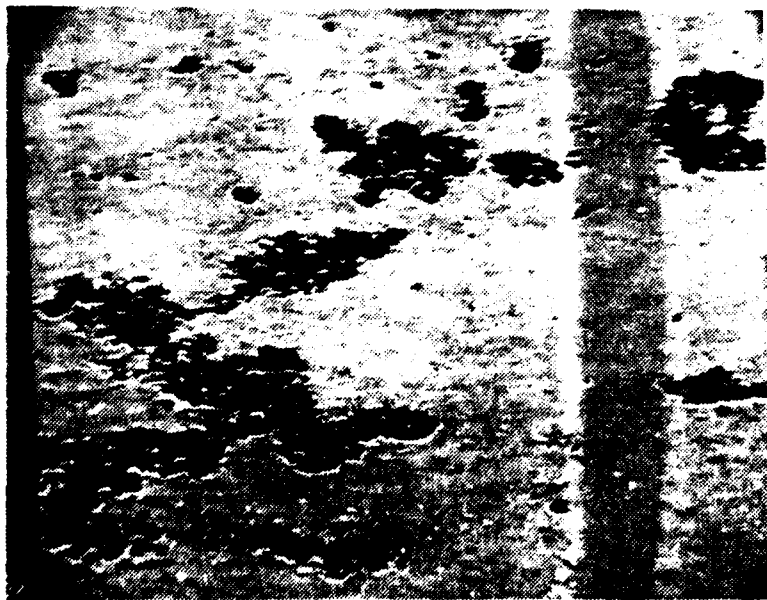
FIGURE 68. GLASS COATED WITH TITANIUM. ENLARGED VIEW OF SMALLER ARC TRACKS. (200X SEM)

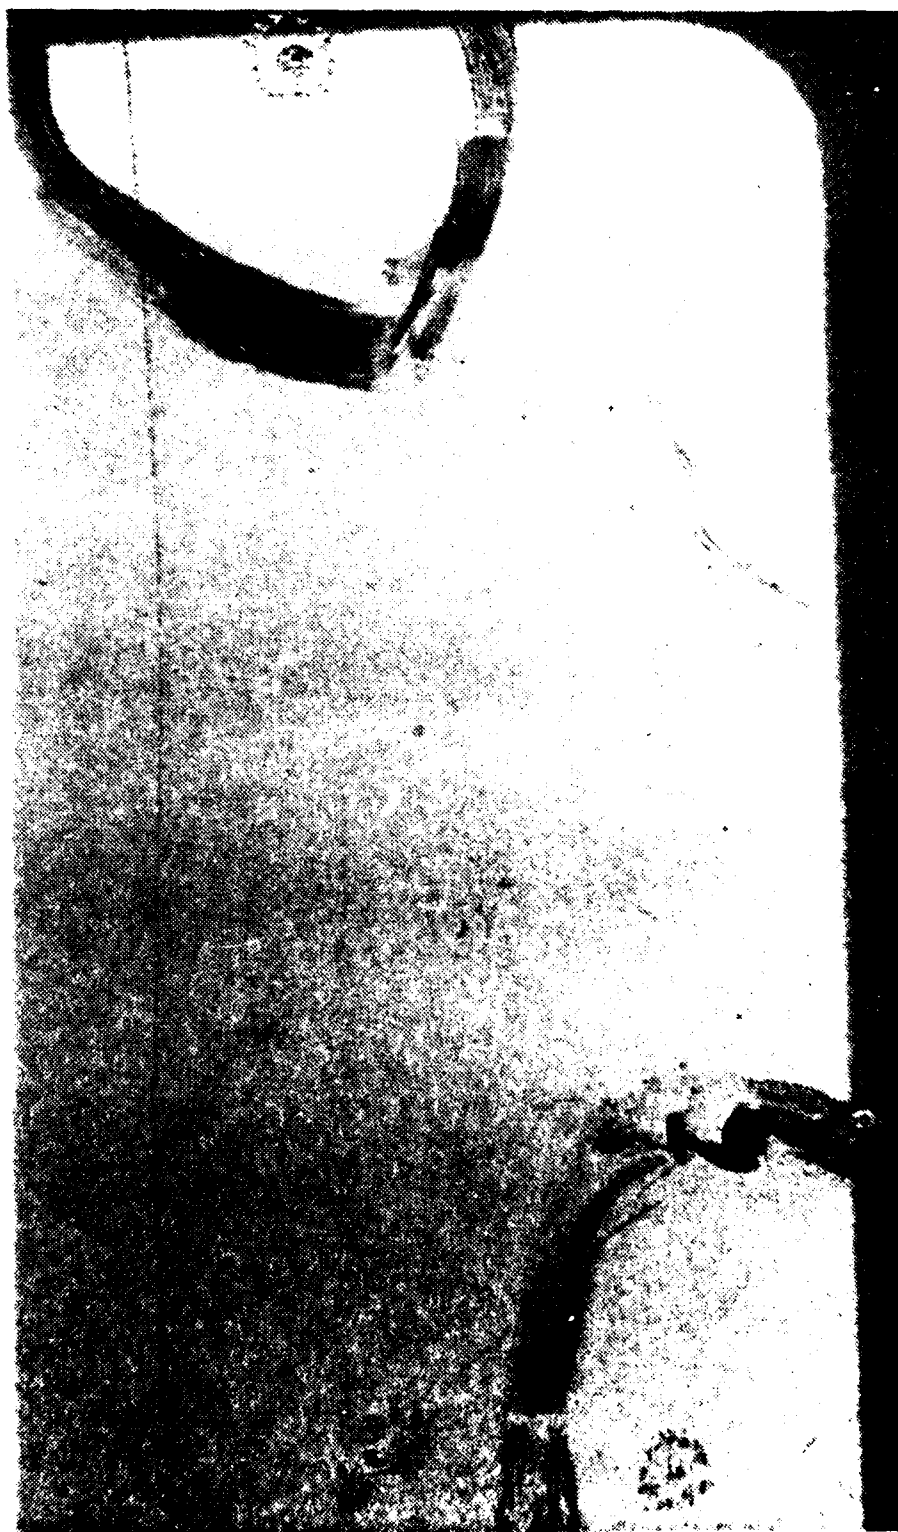
As discussed in a previous section of this paper, any imperfection in an optical element of a laser can lead to self-focusing and damage to the element. It is conceivable that the primary damage areas seen on this sample were caused by direct laser-light pulses striking the glass surface. Since this window does not transmit the 10.6  $\mu$ m CO<sub>2</sub> laser light, the energy would be absorbed by the glass causing damage.

FIGURE 70. MAGNIFICATION OF DAMAGED AREA ON  $\text{CO}_2$  LASER WINDOW.

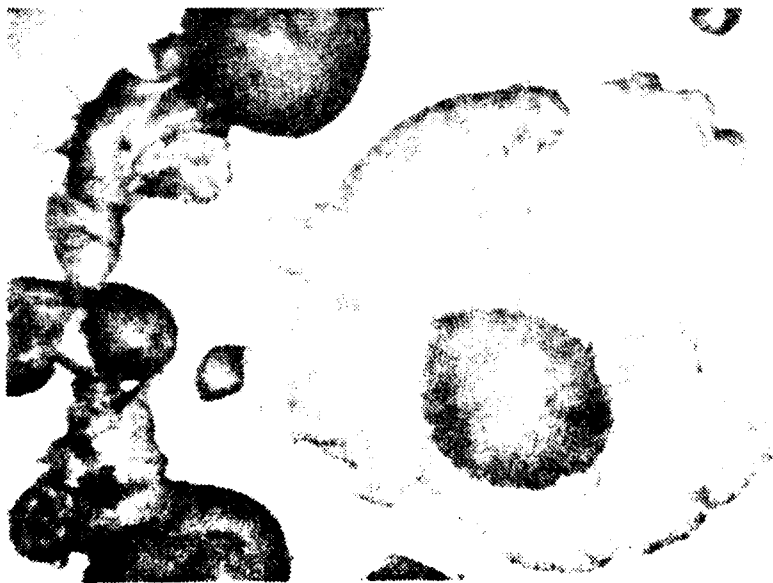
FIGURE 72. DAMAGED AREA ON CO<sub>2</sub> LASER WINDOW. (100X OPTICAL MICROSCOPE)
